TRANSPORT SA

RAPID BAY JETTY
Measurement of Steel Thickness

Project: Rapid Bay Jetty, Steel Thickness Measurement
Client: N. Correani, Marine Facilities
Report No: 05018-2 **Date:** 03/03/2005

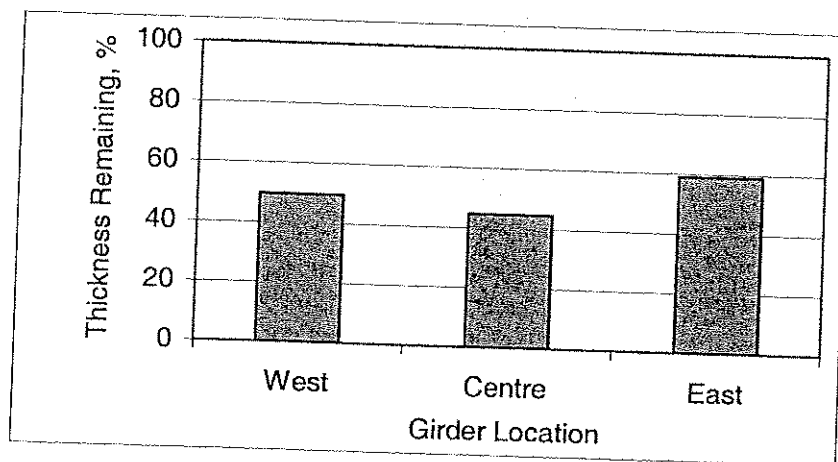
Diagram 1 - Top Flange

A total of 270 measurements were taken on longitudinal girders. Of these, 126 were taken on the top flange, and the results are shown in diagram 1.

Thickness losses ranged from 3% to 100%, with an overall average of 49% from the original thickness of 15.34mm. A summary of measurement data is displayed in Table 1.

The very high Standard Deviation figures indicate the variability of the measurements obtained.

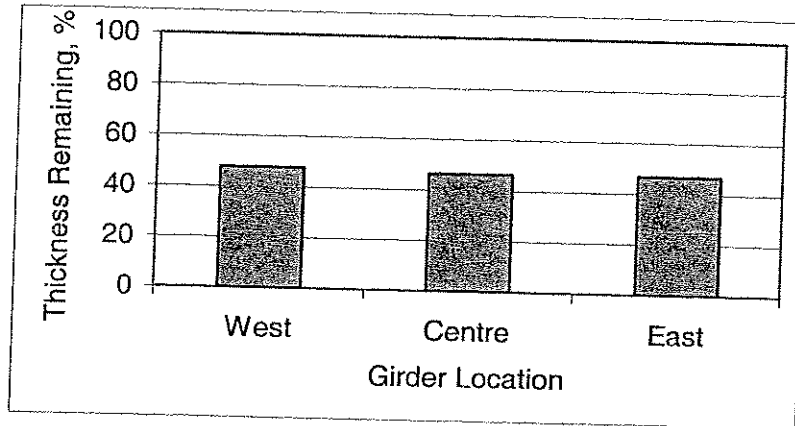
Diagram 2 – Bottom Flanges

A further 81 readings were taken on the bottom flanges, and these results are shown in Diagram 2. Thickness losses ranged from 19% to 100%, with an overall average of 53% from the original thickness of 15.34mm.

A summary of measurement data is displayed in Table 2. The very high Standard Deviation figures indicate the variability of the measurements obtained.

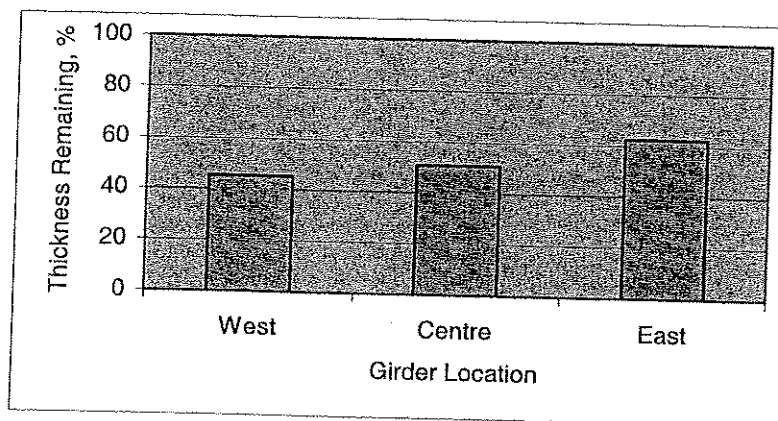
Diagram 3 - Webs

A further 63 readings were taken on the webs, and these results are shown in Diagram 3.

Thickness losses ranged from 0% to 100%, with an overall average of 47% from the original thickness of 12.06mm. Overall it appeared as though the eastern longitudinal girder had suffered the least metal loss.

A summary of measurement data is displayed in Table 3. The very high Standard Deviation figures indicate the variability of the measurements obtained.

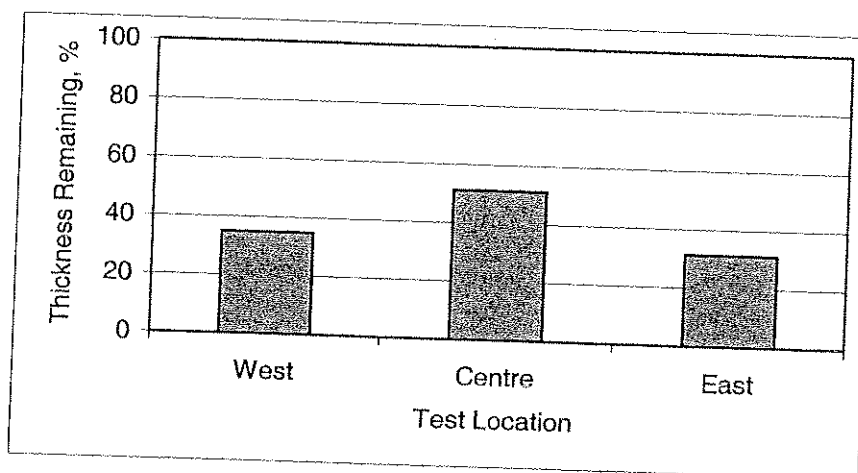
Diagram 4 – Top Flange

A total of 117 measurements were taken on crosshead channels, with 39 of these on the top flange. These results are shown in Diagram 4. Thickness losses ranged from 20% to 100%, with an overall average of 61% from the original thickness of 13.66mm.

A summary of measurement data is displayed in Table 4. The very high Standard Deviation figures indicate the variability of the measurements obtained.

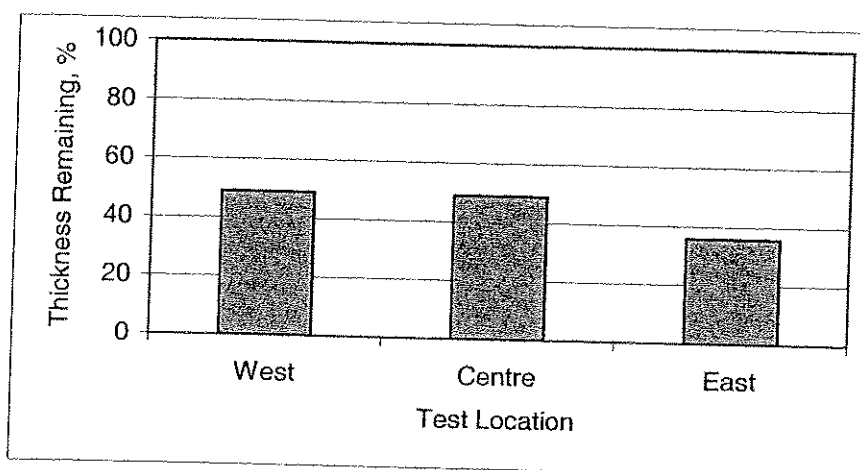
Diagram 5 – Bottom Flange

A total of 39 measurements were taken on the bottom flange, and these results are shown in Diagram 5. Thickness losses ranged from 0% to 100%, with an overall average of 55% from the original thickness of 13.66mm.

A summary of measurement data is displayed in Table 5. The very high Standard Deviation figures indicate the variability of the measurements obtained.

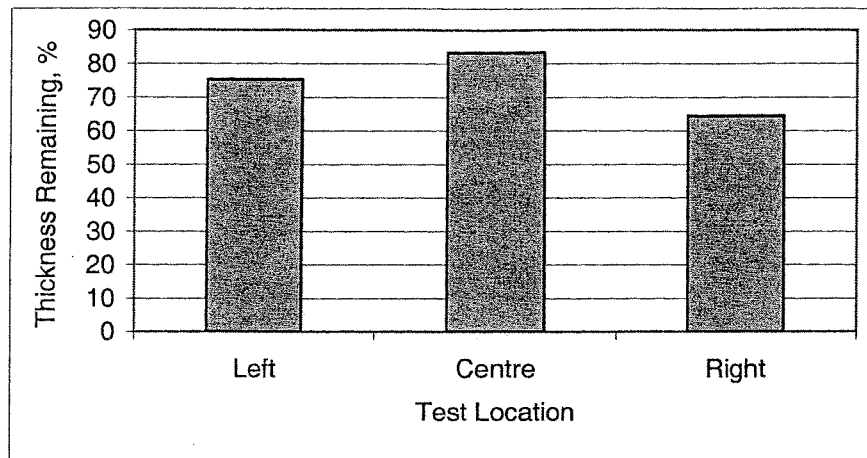
Diagram 6 - Webs

A total of 39 measurements were taken on the webs, and these results are shown in Diagram 6. Thickness losses ranged from 0% to 68%, with an overall average of 26% relative to the nominated original thickness of 10.16mm. This latter figure may however be incorrect, given that 7 of the 39 readings exceeded this figure. Similarly, the Marine and Harbors report of 1987 stated that half of the measurements clearly exceeded this figure, with an overall average for corroded sections of 9.9mm. It would appear as though 12mm may be a more realistic web thickness, and this would significantly impact on the % of metal loss observed.

A summary of measurement data is displayed in Table 6. The very high Standard Deviation figures indicate the variability of the measurements obtained.

All results are summarised in Table 7. Indications are that general metal losses of approximately 50% have been measured over the relevant spans of this structure. I believe that the original thickness figures for the crosshead webs are incorrect, which would result in a greater metal loss figure for these components.

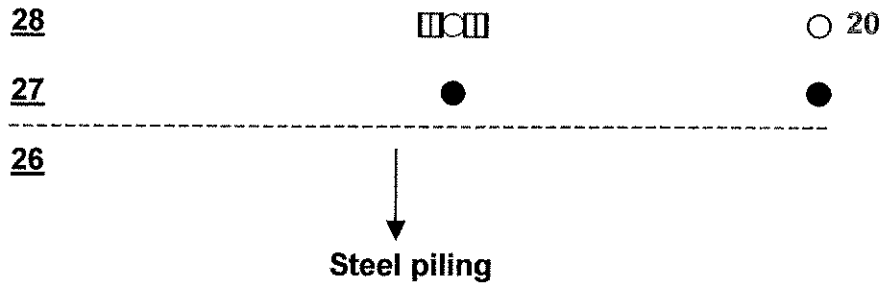
RAPID BAY JETTY – Pile Inspection

- 56 ○ 60 ● 40 ○ 00
- 55 ○ 55 ○ 35
- 54 ○ 60 ○ 45
- 53 ○ 65 ○ 50
- 52 ○ 50 ● 45 ○ 40
- 51 ○ 40 ○ 55
- 50 ○ 55 ○ 45 ○ 30
- 49 ○ 35 ○ 50
- 48 ○ 35 ● 60 ○ 20
- 47 ○ 60 ○ 15
- 46 ○ 30 ○ 50
- 45 ○ 50 ○ 55
- 44 ○ 60 ○ 60 ○ 50
- 43 ○ 45 ○ 30
- 42 ○ 40 ○ 15
- 41 ○ 15 ○ 30
- 40 ○ 35 ○ 50
- 39 ○ 60 ○ 55
- 38 ○ 00 ○ 70
- 37 ○ 60 ○ 70
- 36 ○ 65 ○ 60
- 35 ● 70 ○ 80
- 34 ○ 50 ○ 45
- 33 □□□ ○ 45
- 32 ○ 60 ○ 50
- 31 ○ 20 ○ 60
- 30 ○ 35 ○ 50
- 29 ○ 30 ● 25
