RAPID BAY JETTY
Measurement of Steel Thickness

Project: Rapid Bay Jetty, Steel Thickness Measurement
Client: N. Correani, Marine Facilities
Report No: 05018-2 **Date:** 03/03/2005

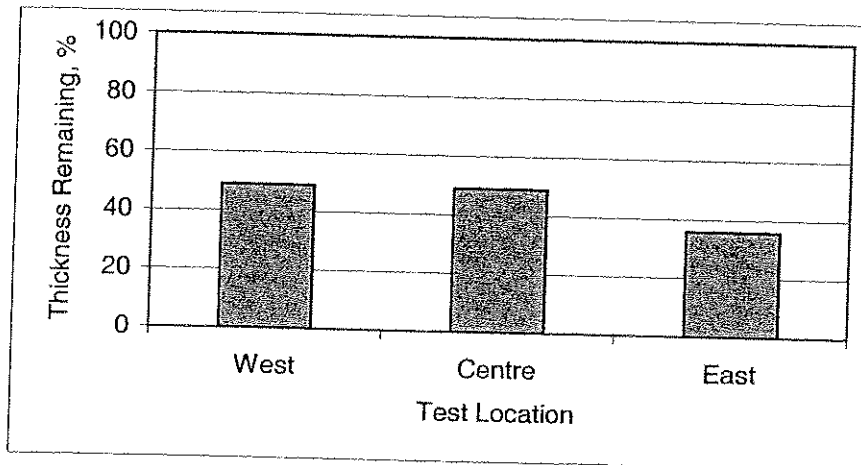
Diagram 5 – Bottom Flange

A total of 39 measurements were taken on the bottom flange, and these results are shown in Diagram 5. Thickness losses ranged from 0% to 100%, with an overall average of 55% from the original thickness of 13.66mm.

A summary of measurement data is displayed in Table 5. The very high Standard Deviation figures indicate the variability of the measurements obtained.
