RAPID BAY JETTY
Measurement of Steel Thickness

Project: Rapid Bay Jetty, Steel Thickness Measurement
Client: N. Correani, Marine Facilities
Report No: 05018-2 **Date:** 03/03/2005

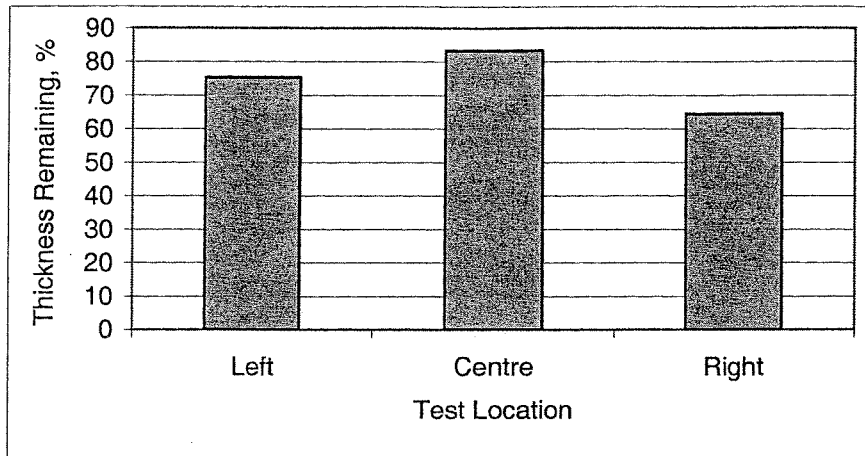
Diagram 6 - Webs

West	Centre	East
Thickness New, mm	10.16	10.16	10.16
Mean Webs, mm	7.7	8.5	6.6
Standard Deviation	3.1	3.4	2.0
