SEACON AUSTRALIA PTY.LTD.
ACN 057 864 169

Ref. : Underwater Inspection of the Rapid Bay Jetty piles.

RAPID BAY JETTY

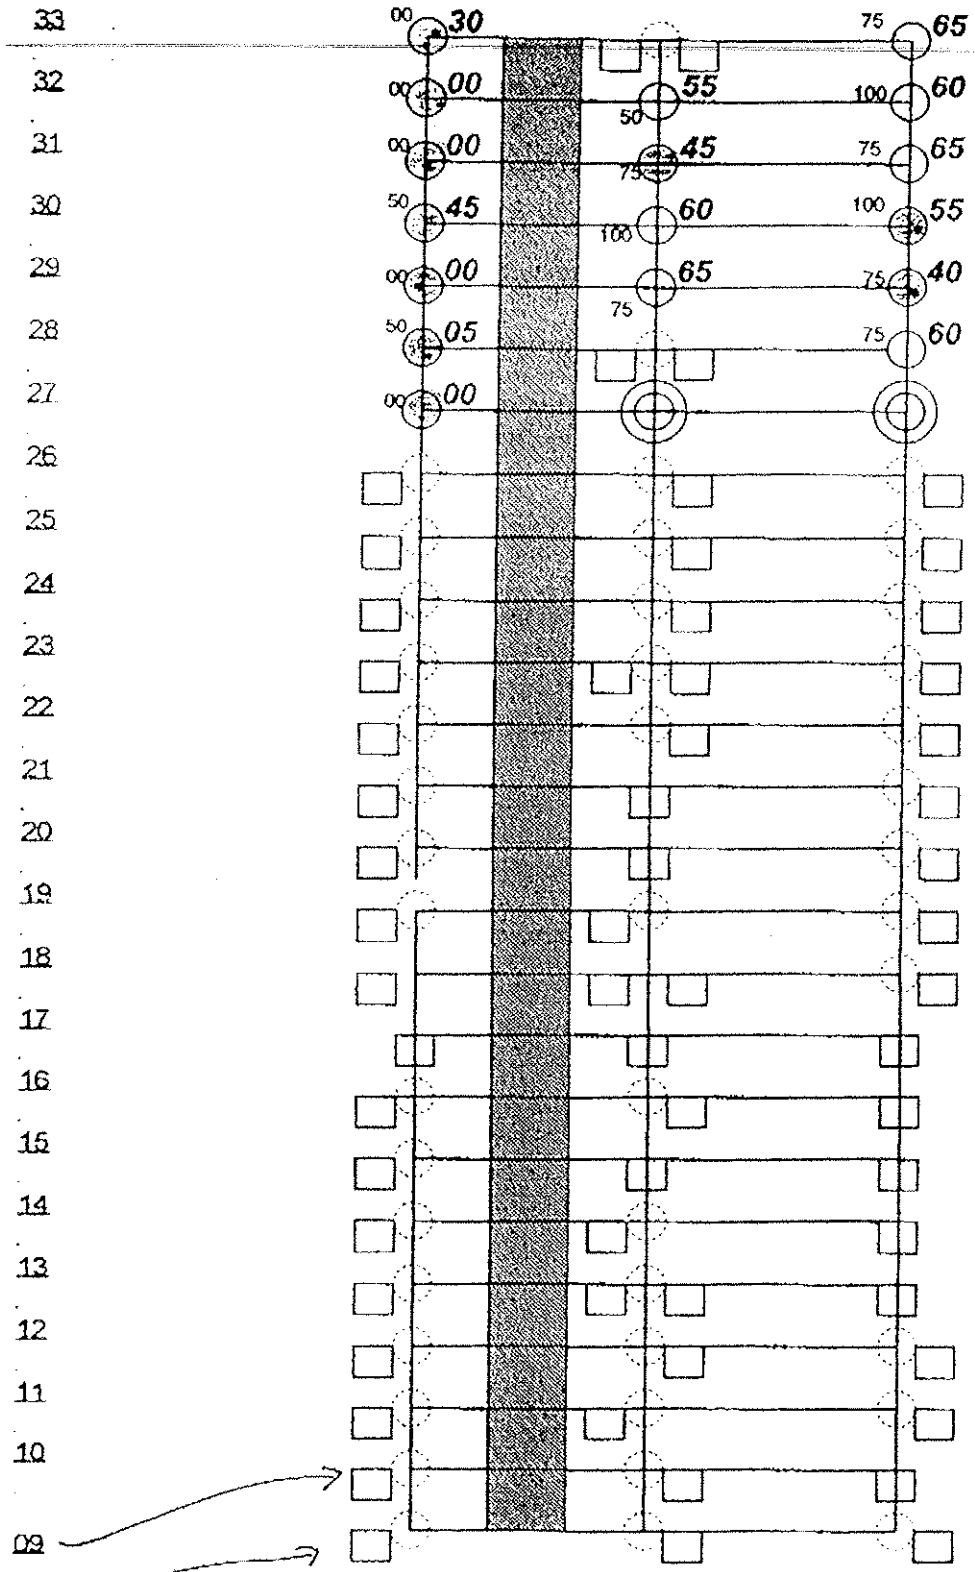
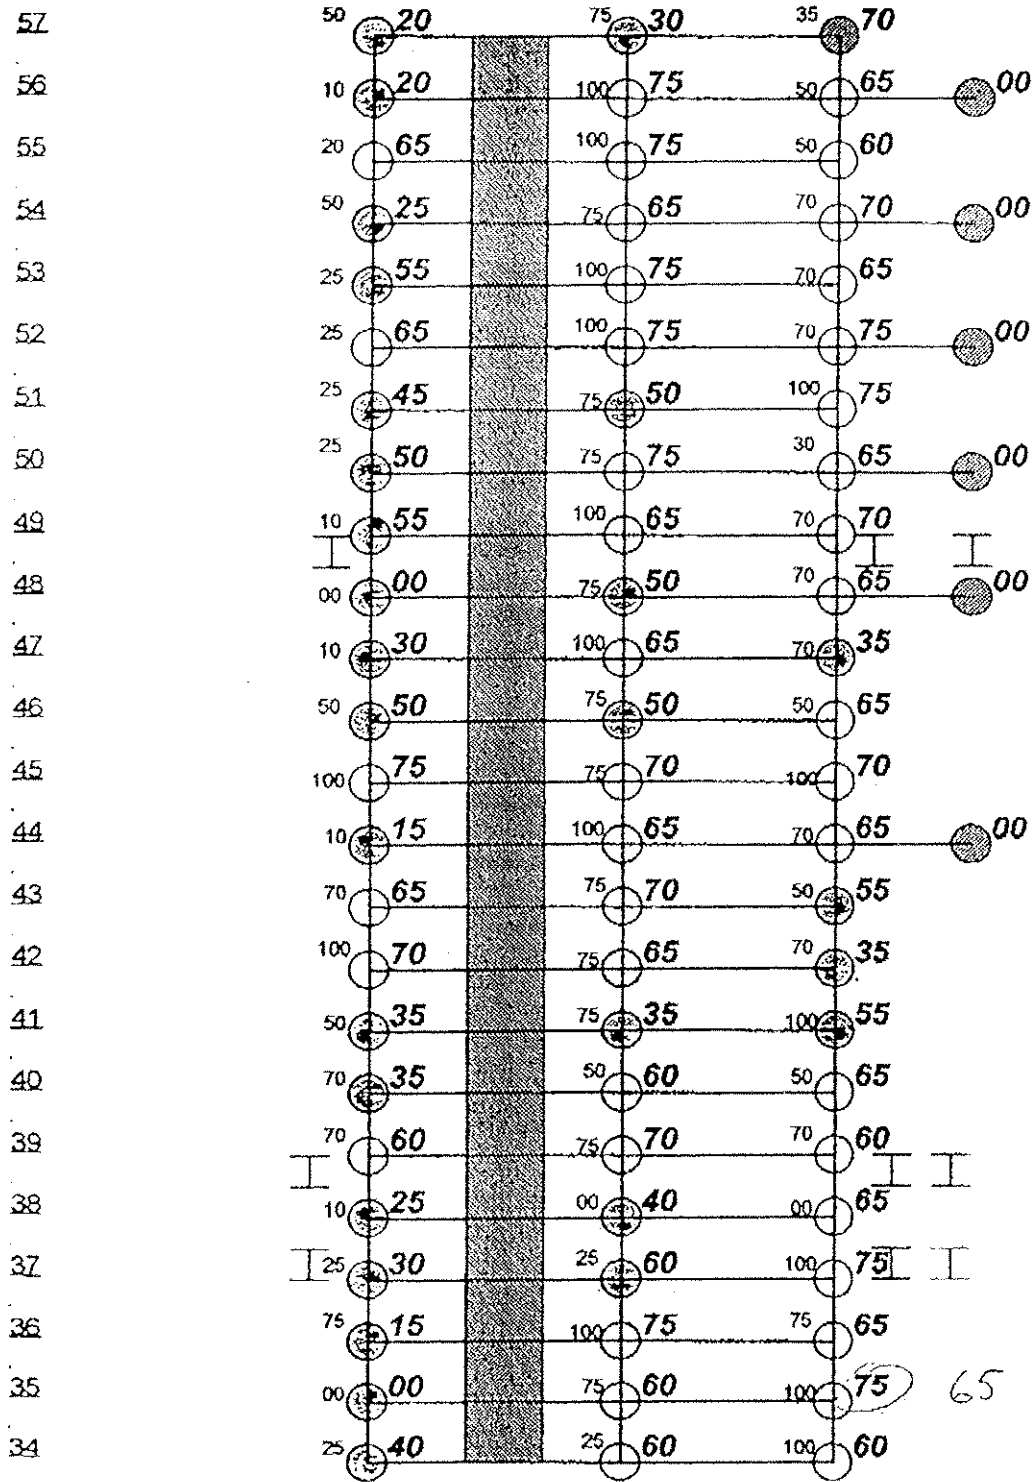
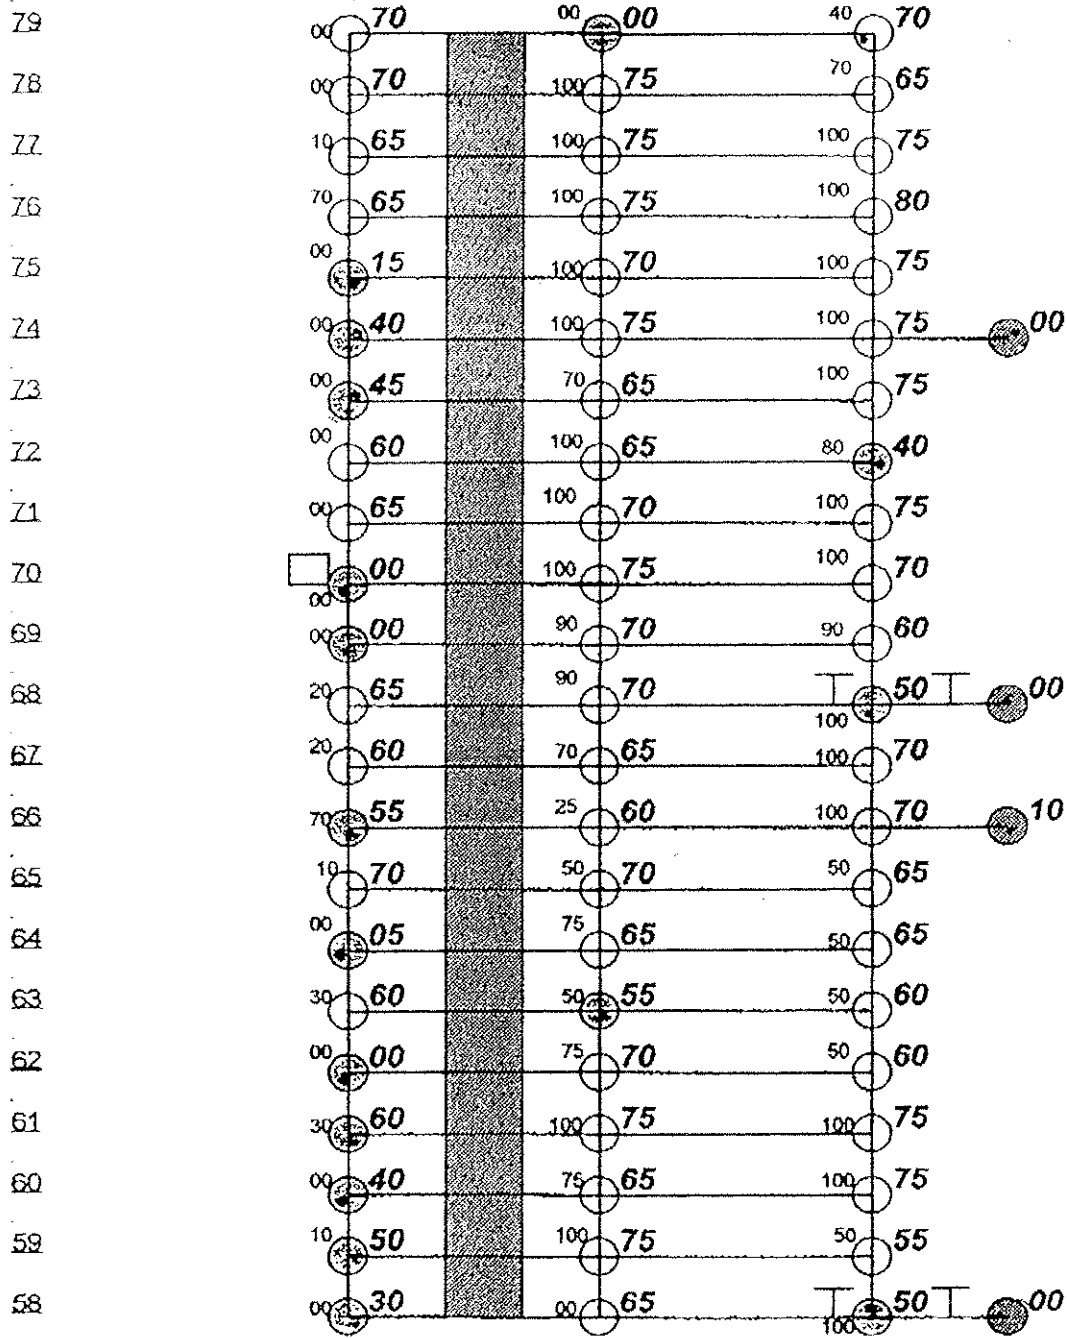
- There was extensive Toredoworm infestation throughout the timber piled section of the jetty.
- The timber piles had been previously encased in concrete to approximately the low water line.
- This concrete encasement has failed on the majority of piles, as indicated on the accompanying pile % diagram.
- Inspection percentages were of the timber left exposed on each pile.
- The piles in position 4 of the diagram are batter piles.
- The deck had been removed between piles 1 & 2 along the length of the jetty as inspected, with the exception of the area between Bents 37 & 39 which has been left as an elevated platform.
