Ref. : Underwater Inspection of the Rapid Bay Jetty piles.

RAPID BAY JETTY

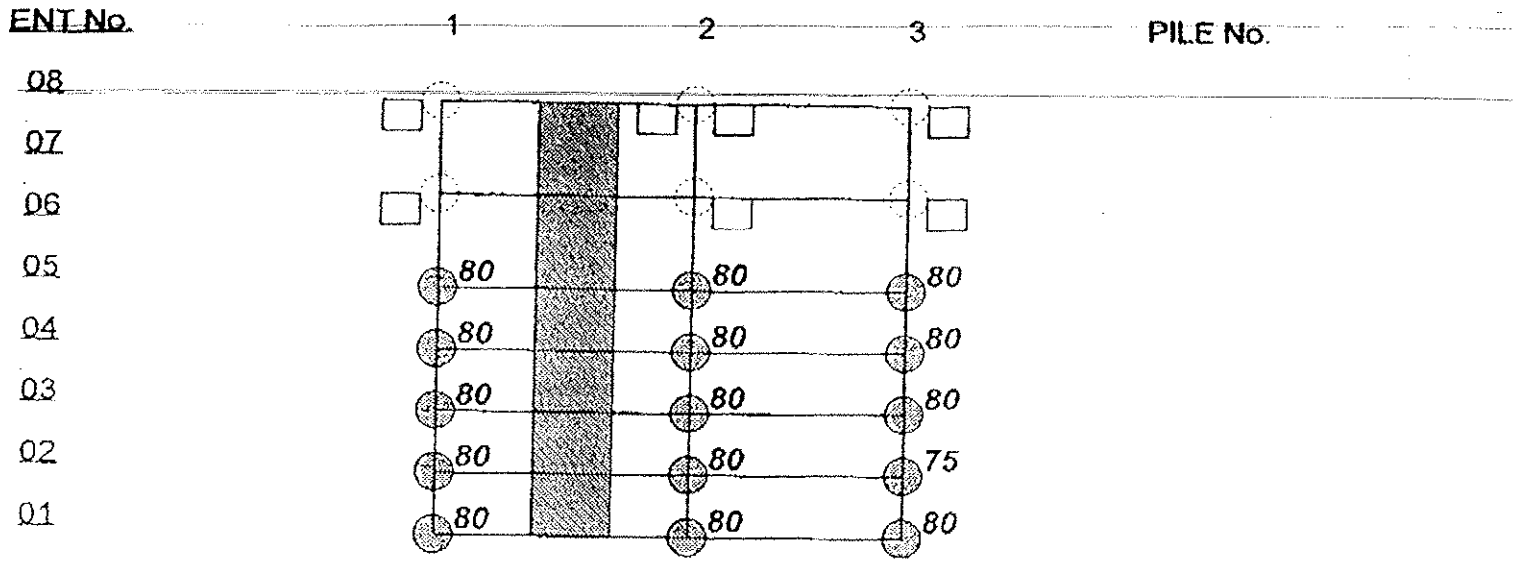
- There was extensive Toredoworm infestation throughout the timber piled section of the jetty.
- The timber piles had been previously encased in concrete to approximately the low water line.
- This concrete encasement has failed on the majority of piles, as indicated on the accompanying pile % diagram.
- Inspection percentages were of the timber left exposed on each pile.
- The piles in position 4 of the diagram are batter piles.
- The deck had been removed between piles 1 & 2 along the length of the jetty as inspected, with the exception of the area between Bents 37 & 39 which has been left as an elevated platform.
