TO:           MANAGER, ENGINEERING SERVICES *J. Kelly*  
              REGIONAL ENGINEER (CIVIL)

SUBJECT:    RAPID BAY JETTY - UPDATE ESTIMATE

DATE:       11 May 1992

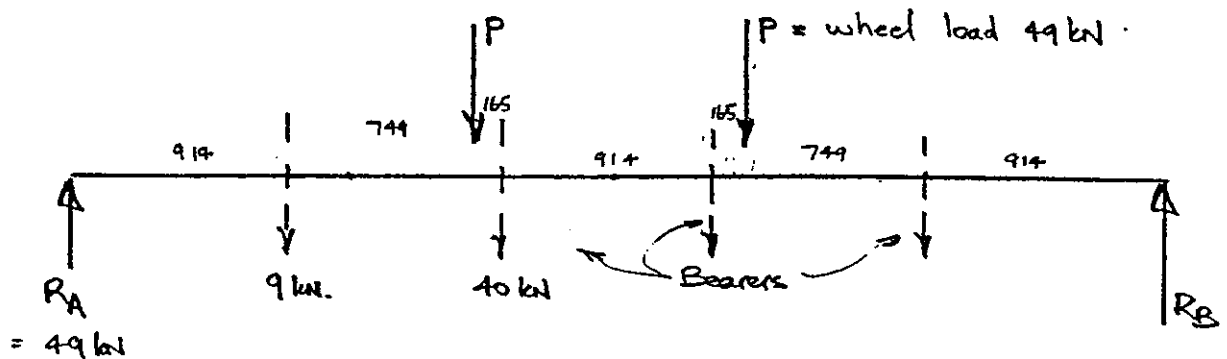
Construction load P @ H325

$$M_{\text{Max}} = (49 \times 2.235) - (9 \times 1.371) - (40 \times 0.457)$$

$$= \underline{79 \text{ kN.m.}}$$

$$Z_{\text{original girder section}} = 715 \times 10^3 \text{ mm}^3$$

$$f_b = \frac{79 \times 10^6}{715 \times 10^3} = 112 \text{ MPa.} < 165$$

$$1987 \text{ Corroded section } Z = 469 \times 10^3 \text{ mm}^3 \quad [1987 \text{ report pg. 15}]$$

$$f_b = \frac{79 \times 10^6}{469 \times 10^3} = 168 \text{ MPa.} \approx 165$$

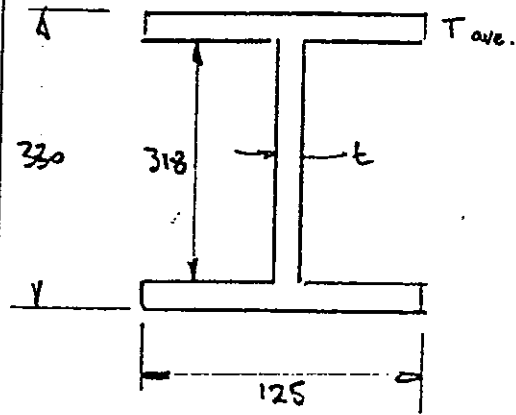
loss in T =  $10.18 \times 52 \text{ yrs} = 9.3 \text{ mm}$   
Sag 9 mm

$T_{1992} = 15 - 9 = \underline{6 \text{ mm}}$

loss in t =  $0.05 \times 52 = 2.6 \text{ mm}$

$t_{1992} = 12.5 - 2.6 = 9.9$   
Sag 10 mm

$$I_{1992 \text{ section}} = \frac{10 \times 318^3}{12} + (2 \times 6 \times 125 \times 162^2)$$

$$= 66 \times 10^6 \text{ mm}^4$$

$$Z = 401 \times 10^3 \text{ mm}^3$$

$$f_b = \frac{79 \times 10^6}{401 \times 10^3} = \underline{197 \text{ Mpa}} \quad \neq 165$$

Assumed web & flange thicknesses are derived from measurements taken in 1937. These measured values were the the most severe recorded locally and are not consistent throughout the full length of the girders.
