## EIA Services for New Rapid Bay Jetty

### ENVIRONMENTAL ASSESSMENT

- Final Report
- 30 March 2007

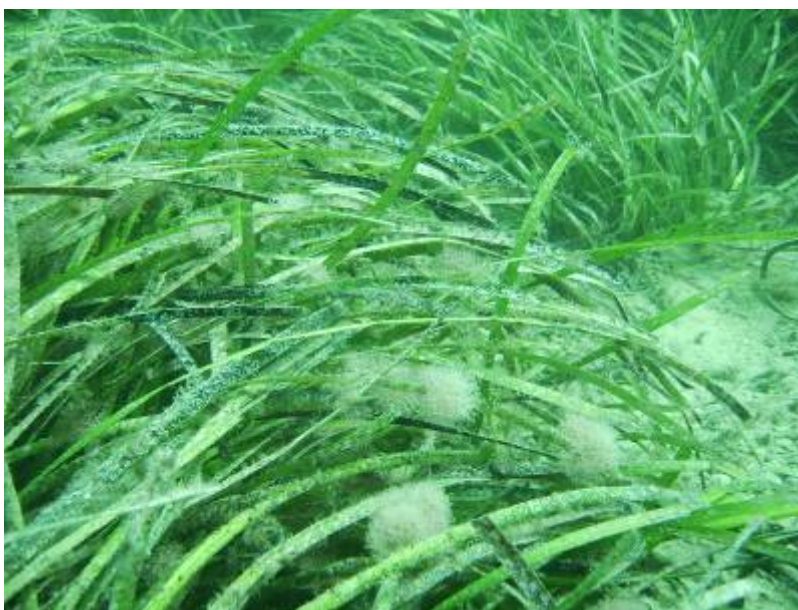
■ **Figure 3** The seagrass, *Posidonia sinuosa*

The seagrass, *P. sinuosa* (Figure 3) was the dominant seagrass species near Rapid Bay Jetty, particularly between six and nine metres in depth. Although it was also common in the shallower inshore areas it did not occur as an extensive meadow as in the deeper water. *Posidonia* species are the dominant seagrass in South Australian waters, particularly in Gulf St Vincent and Spencer Gulf where they occupy more than 5,000 km<sup>2</sup> (Kirkman 1997).

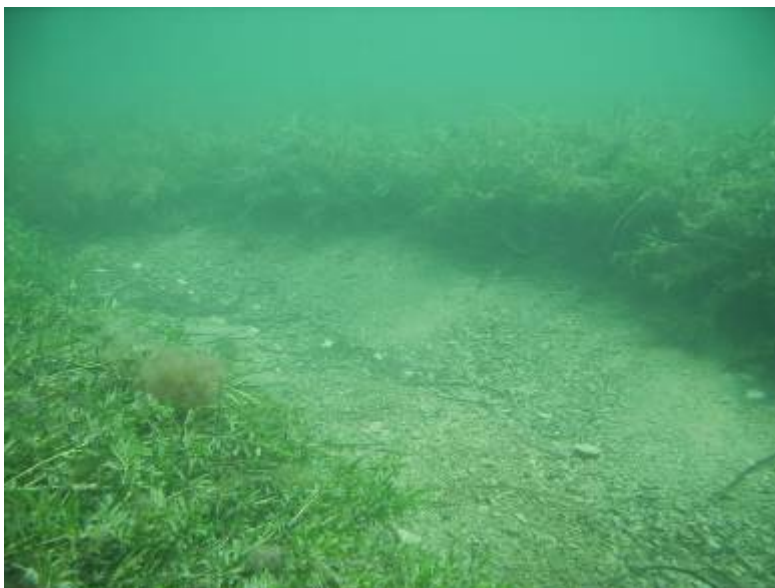
■ **Figure 4 Blowout in Seagrass Meadow**

Blowouts (Figure 4) in the *Posidonia* meadow were noted at several locations, including around the end of the proposed jetty. These can occur naturally due to severe storm damage and may explain the total absence of *Posidonia* between three and six metres in depth to the east (and west) of the existing jetty.

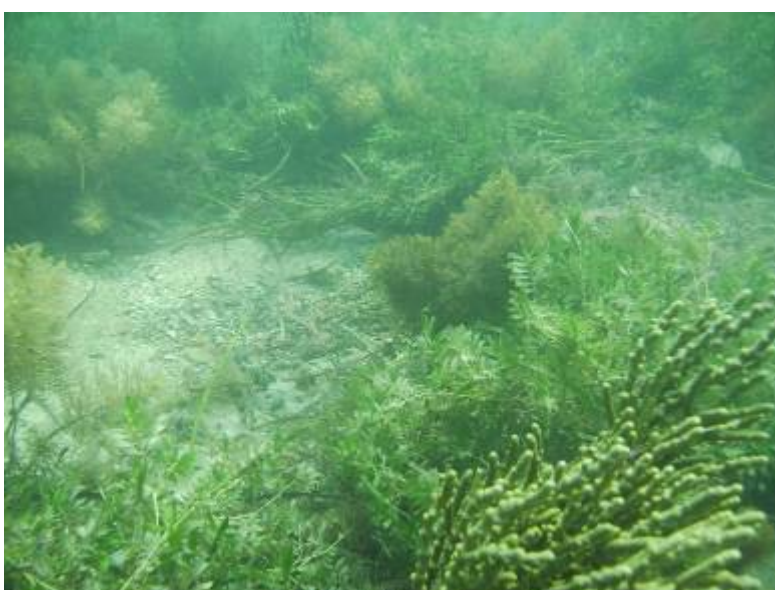
■ **Figure 5 Typical Mixed Seagrass/Macroalgae Habitat**

Much of the inshore areas were covered by dense seagrass and macroalgae. Figure 5 shows a variable cover of *Amphibolis griffithii* interspersed with patches of *Caulocystis* and *Scaberia*.

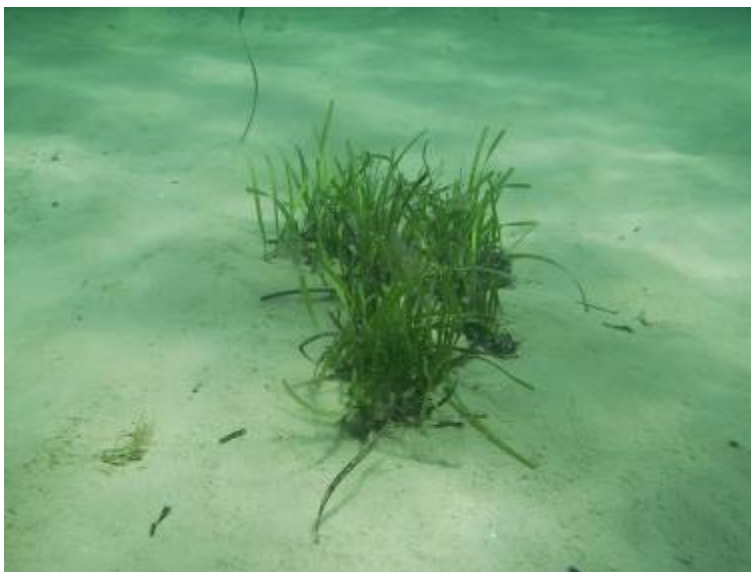
■ Figure 6 Patchy cover of *P. sinuosa*

Much of the area to the west of the existing jetty consisted of patchy areas of seagrass (both *Posidonia* and *Amphibolis*) interspersed with large areas of sand and gravel. Many of the patches were relatively small (Figure 6) and could not be mapped at the appropriate scale.

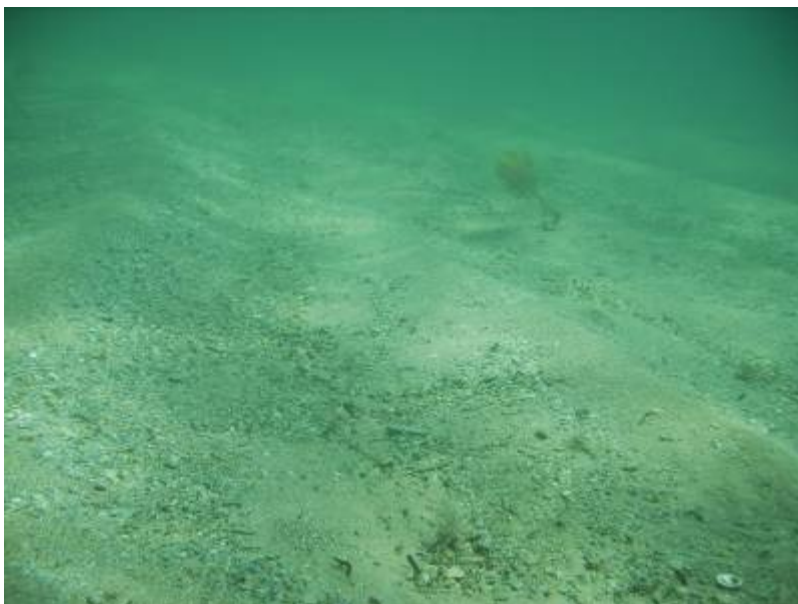
■ **Figure 7 Typical Seabed along Proposed Jetty Alignment**

Much of the proposed jetty alignment overlies areas of bare sediment. The sediments consist of coarse gravel and sand but smaller areas of fine sand were noted to the east of the existing Jetty. Figure 7 shows typical seabed conditions in the immediate vicinity of the proposed jetty alignment. The seabed was contoured by sand waves, indicating the area is probably exposed to significant wave energy.

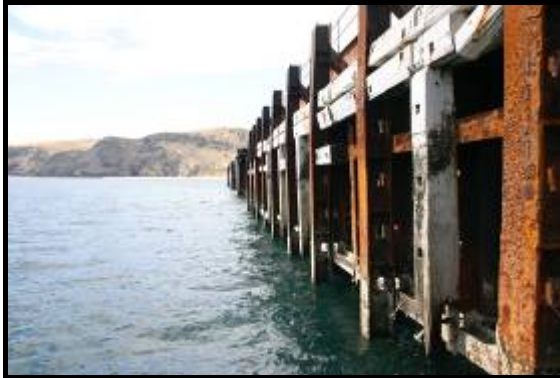
Decay of piles at seaward end of Jetty

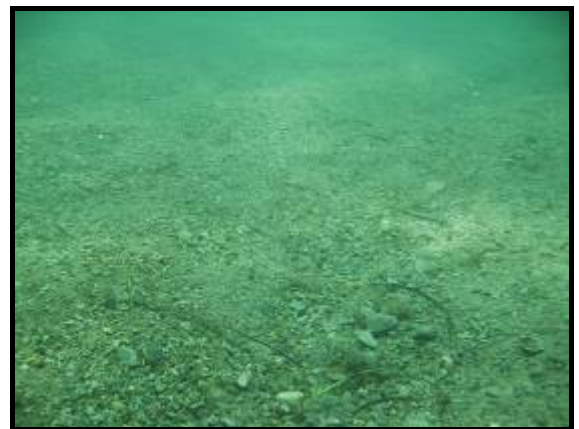
Seabed along proposed jetty alignment near Offshore Test Pile Site

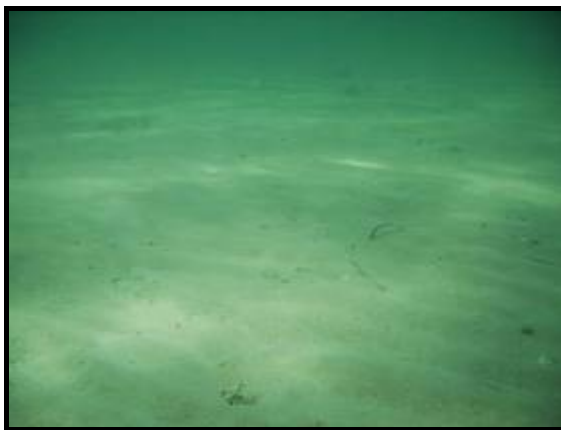
Seabed along proposed jetty alignment near  
Inshore Test Pile Site (Site 484)
